Manhole Inspection Summary

Manhole # S09SS_002MH

Insp Date: **5/10/07 1:42 PM**

Location Address: **3004 HILTON ST** Cross Street: **FAIRVIEW AVE**

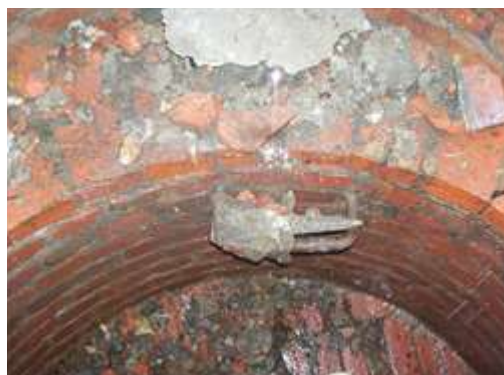
Defect 4

DEBRIS ON BOTH BENCHES

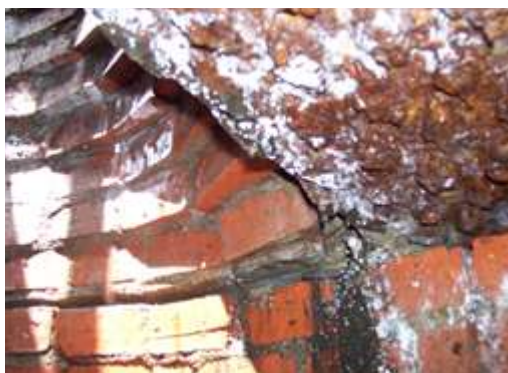
Defect 3

INFILTRATION DRIFTER- FLAT TOP OF CORBEL

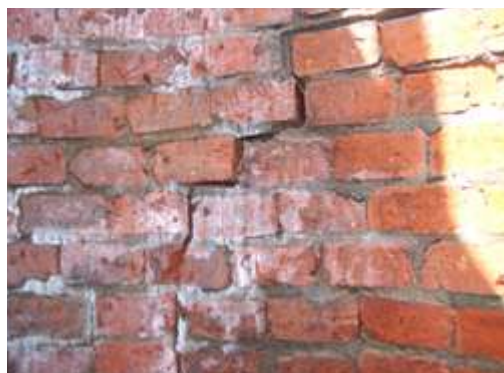
Defect 2

Condition: ☐ Sound ☒ **Cracked** ☐ Root Intrusion ☐ Loose Brick ☐ Deteriorated

Infiltration: ☐ None ☐ Joint ☒ **Cracks** ☐ Mortar ☐ Roots ☐ Wall

BREAK IN OPPOSITE SIDE OF BARREL
CONNECTING TO BREAK # 1

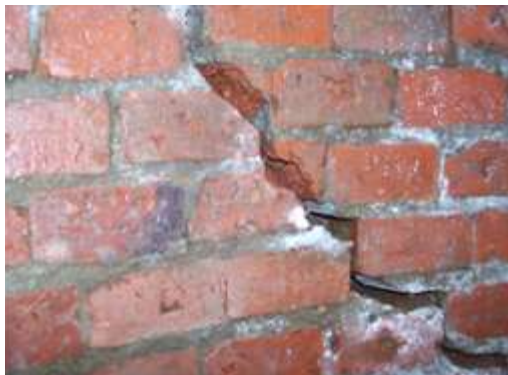
Defect 1

DETERIORATED AT BARREL

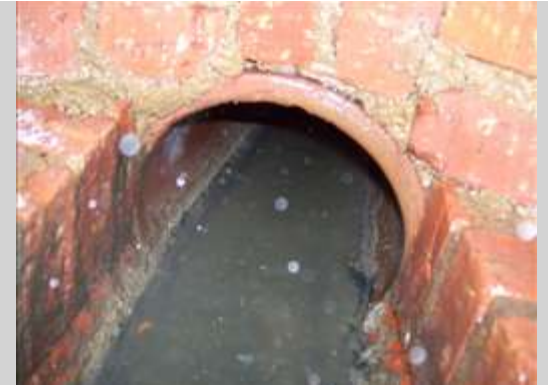
12 O'Clock Outflow

Pipe Height: (in.) Direct
Pipe Material: **Clay** ☐ Pipe Lined
Invert Depth: **11.00** (ft.) Flow Characteristics: **Slow**
Deposits: ☐ None ☐ Mud ☐ Sludge ☒ **Debris** ☐ Grease
Silt Depth: **0.25** (in.) Deposits Extent: **Light**
Infiltration: **None** Pipe Seal Cond: **Cracked**

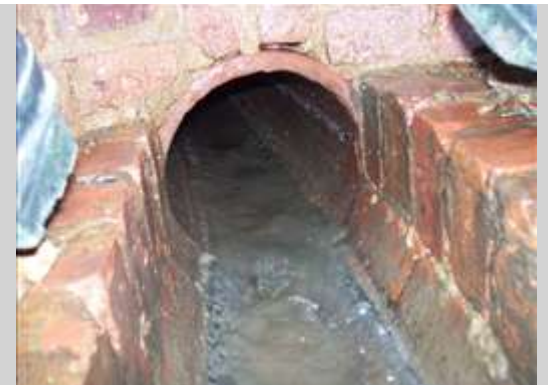
6 O'Clock Inflow

Pipe Height: (in.) Direct
Pipe Material: **Clay** ☐ Pipe Lined
Invert Depth: **10.95** (ft.) Flow Characteristics: **Slow**
Deposits: ☒ **None** ☐ Mud ☐ Sludge ☐ Debris ☐ Grease
Silt Depth: (in.) Deposits Extent:
Infiltration: **None** Pipe Seal Cond: **Cracked**
